Collapse of Braced Excavation in Singapore

Ishihara, Kenji

ABSTRACT: After the collapse of the subway excavation in the Nicoll Highway, extensive in-situ investigations were carried out to identify causes of the accident. The results of detailed studies disclosed that lack of toe-in depth of the diaphragm wall into the stiff competent strata could be one of the causes of the incident. This aspect of the studies is highlighted in this paper.

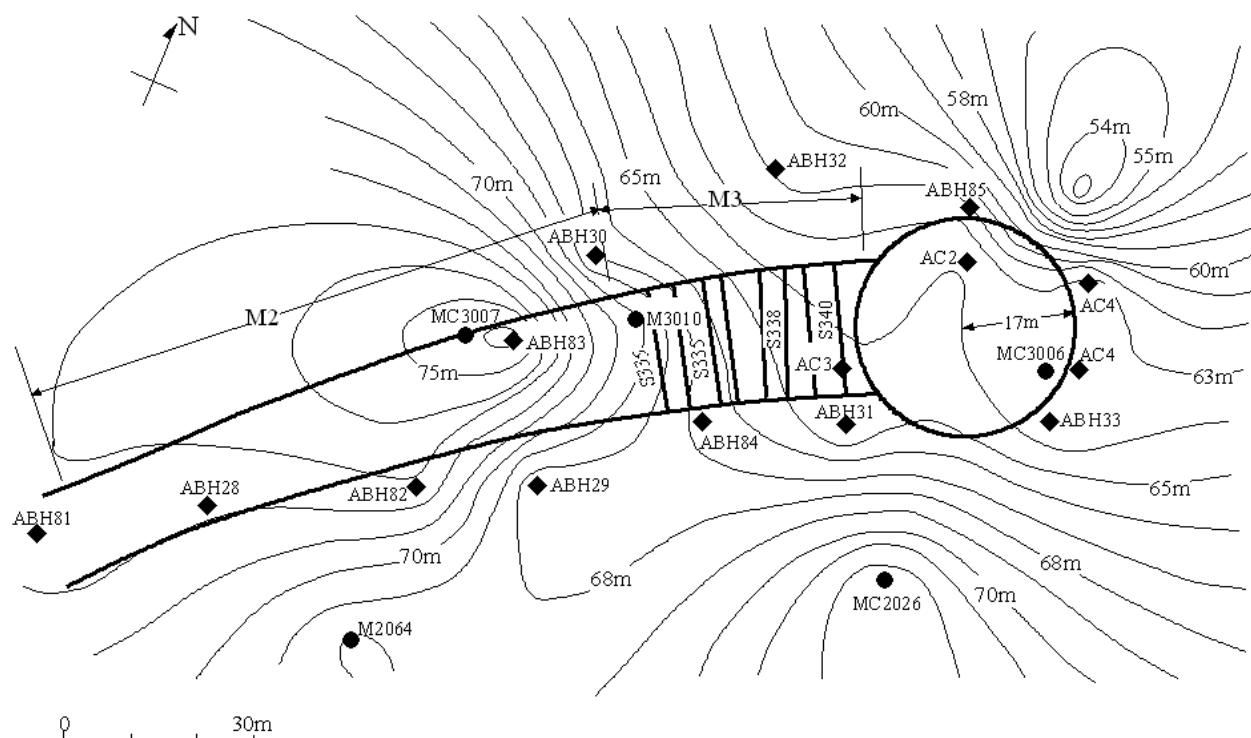
In view of its importance, the contour lines indicating equal elevations of the top of the OA layer were also drawn in Fig. 8, on the basis of the information available at the design stage. It is noted in Fig. 8 that the distance between two adjacent boring logs was no shorter than about 20m and consequently the buried valley near the southern wall close to the access shaft was not identified. This fact turned out to be vital for creating the worst situations to occur afterwards.

Fig. 8. Contours of elevation at the top of the old alluvium (OA-layer) based on boring data at the design stage.

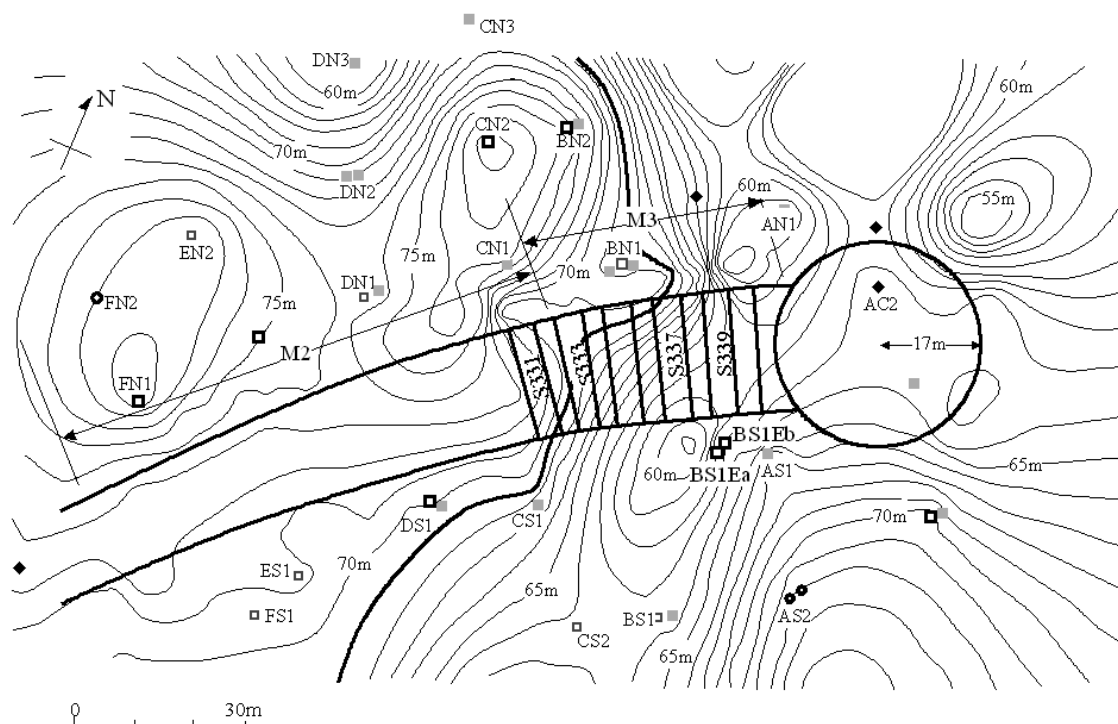
Fig. 10 Counter of elevation at the top of the old alluvium (OA-layer) based on boring data after the collapse.

By compiling all the data made available after the collapse, the contour lines of the top of the OA layer were established as demonstrated in Fig. 10 with a higher level of accuracy as compared to that shown in Fig. 8 which was made up with the boring data at the time of the feasibility study and the design. The contour lines in Fig. 10 unveil some important features as follows which had not been identified in the previous map in Fig. 8.

- (1) There exists a steeply depressed buried valley at the location on the south side a few meters south of the strut S336 and S337. The bottom of the buried valley has an elevation of about 59m RL. The buried valley dips steeply towards the east from the south end of struts S331.

- (2) The buried valley extends towards the north-east running on the west side of the tunnel access shaft (TSA).
- (3) As typically observed in the soil profiles at BS1Ea and BS1Eb in Fig. 11, the SPT N-value tends to increase at the elevation of 67m RL upon hitting the base layer OA. The SPT N-values corresponding to the transition zone below the OA layer were collected from other borings and shown together in Fig. 16 by choosing the nominally identified top of the OA layer as zero point. It may be seen that the property of soils is not so competent with a SPT N-value less than about 30 to a depth of about 3m from the top of the OA layer.

In the area of complicated geological setting, existence of buried valleys should be suspected at the stage when projects are put forward. In such a case soil investigations need to be carried out at a spacing closer than that normally adopted. In addition, properties of soil materials within the buried valley should be investigated in details, if it is discovered. The outcome of these studies should be meticulously reflected on the grand planning as well as on detailed design of the soil-structure system considering each phase of construction processes.

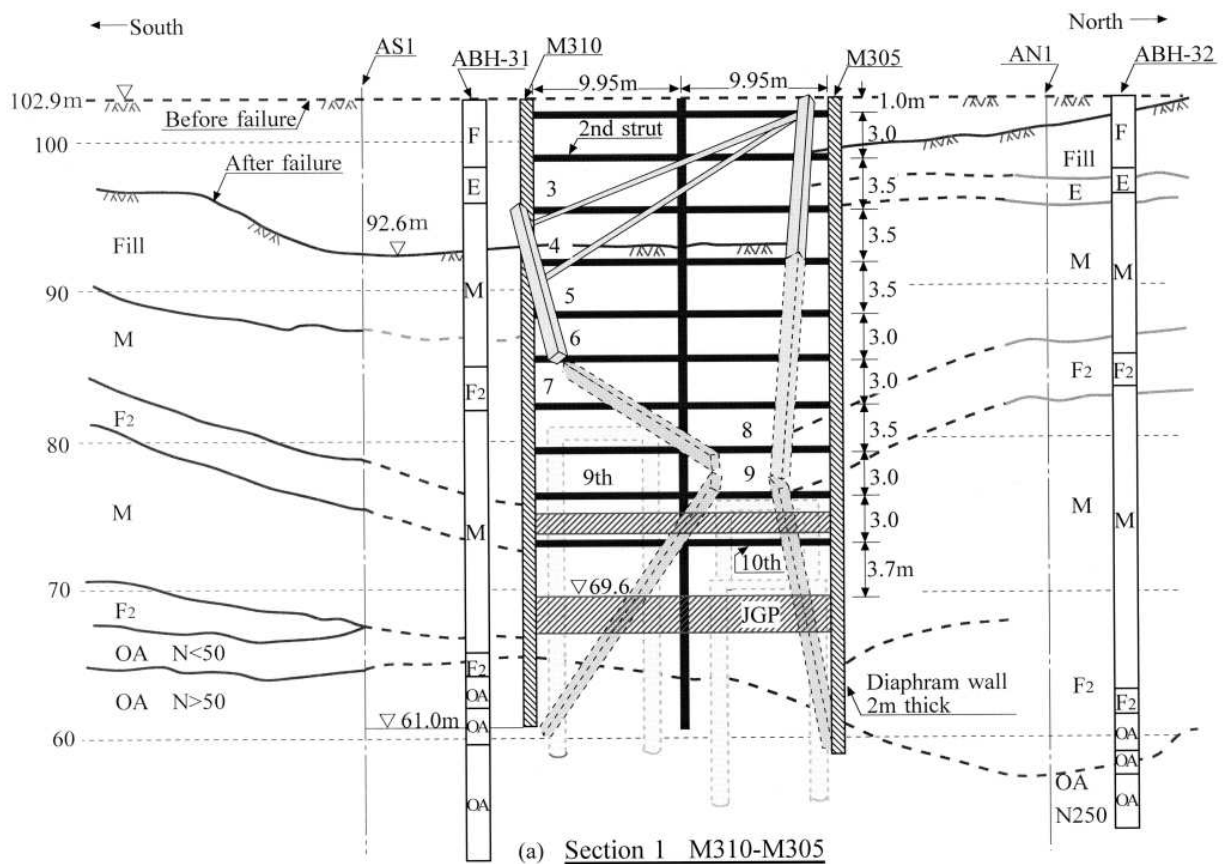
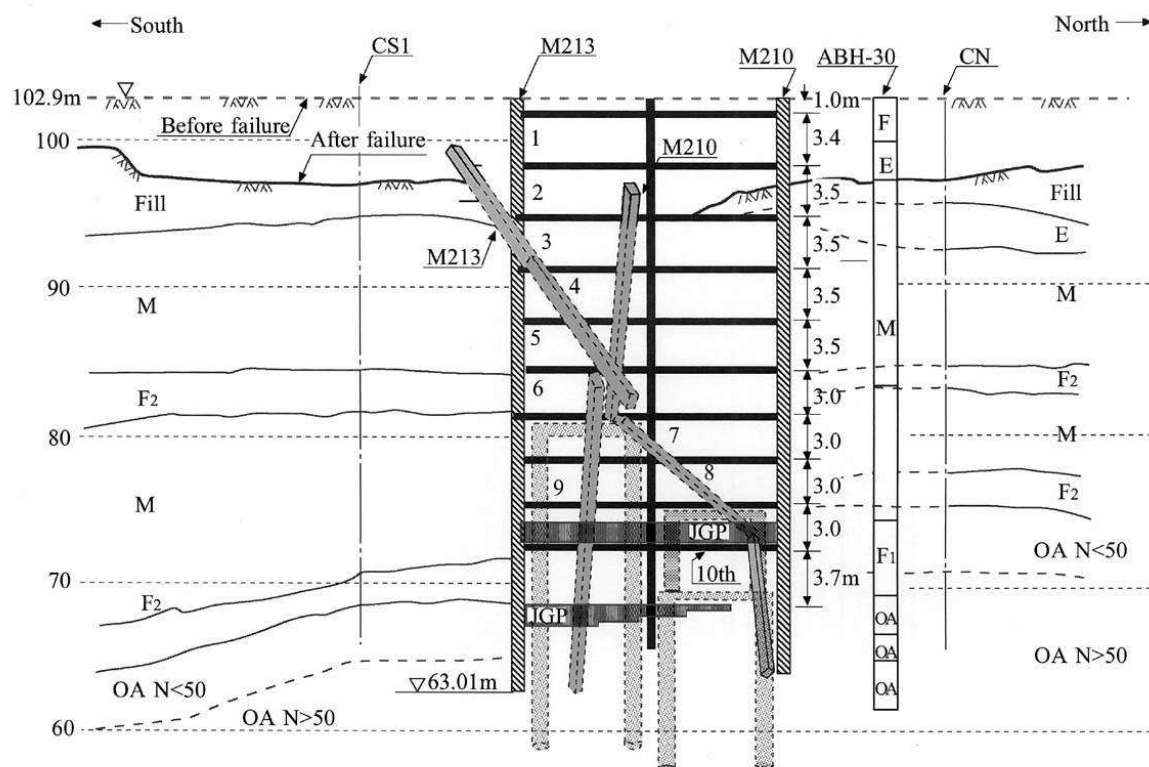
As a result of the post-incident in-situ investigations as above, it became possible to figure out approximately the states of collapse for each of the cross sections indicated in Fig. 14. Shown in Fig. 15 are probable features of the collapsed water-strut system buried within the ground which were speculated for the cross section 1, 5 and 7. It is to be noticed that in the cross section 1 and 5, the intermediate layer F_2 is inclined towards the excavation as verified by the boring data at ABH31 and 32 and also at AS1 and AN1 conducted after the failure. This is indicative of the settlement of the even deep-seated soil layer involved in the slide.

(b) Section 5 M306-M301

(c) Section 7 M213-M210

Fig.15 Cross sections showing the mode of collapse in the zone of failure.

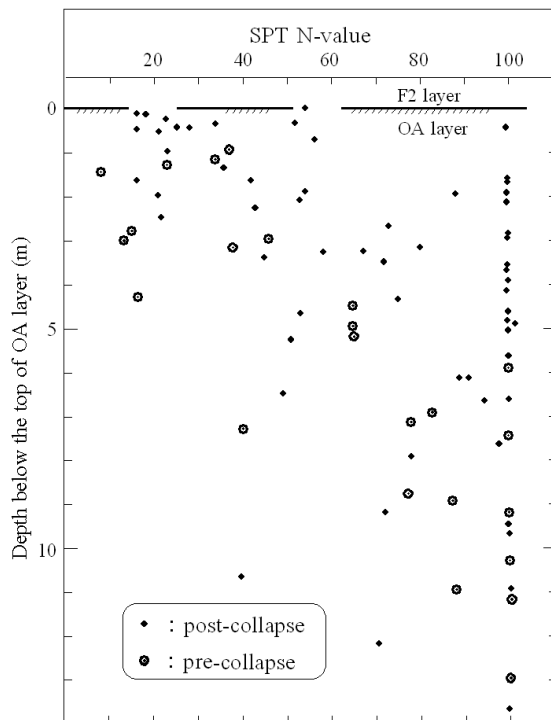
Fig.16. SPT N-values from the top of the OA layer

With regard to the latter suspect, closely-spaced soil investigations revealed that the upper part of the OA layer in the buried valley is comprised of sands, silts and clays sometimes containing organic materials with the SPT N-value not greater than 30 as demonstrated in Fig. 16. This fact indicates that the infill materials were not necessarily as competent as they had been expected at the design stage.

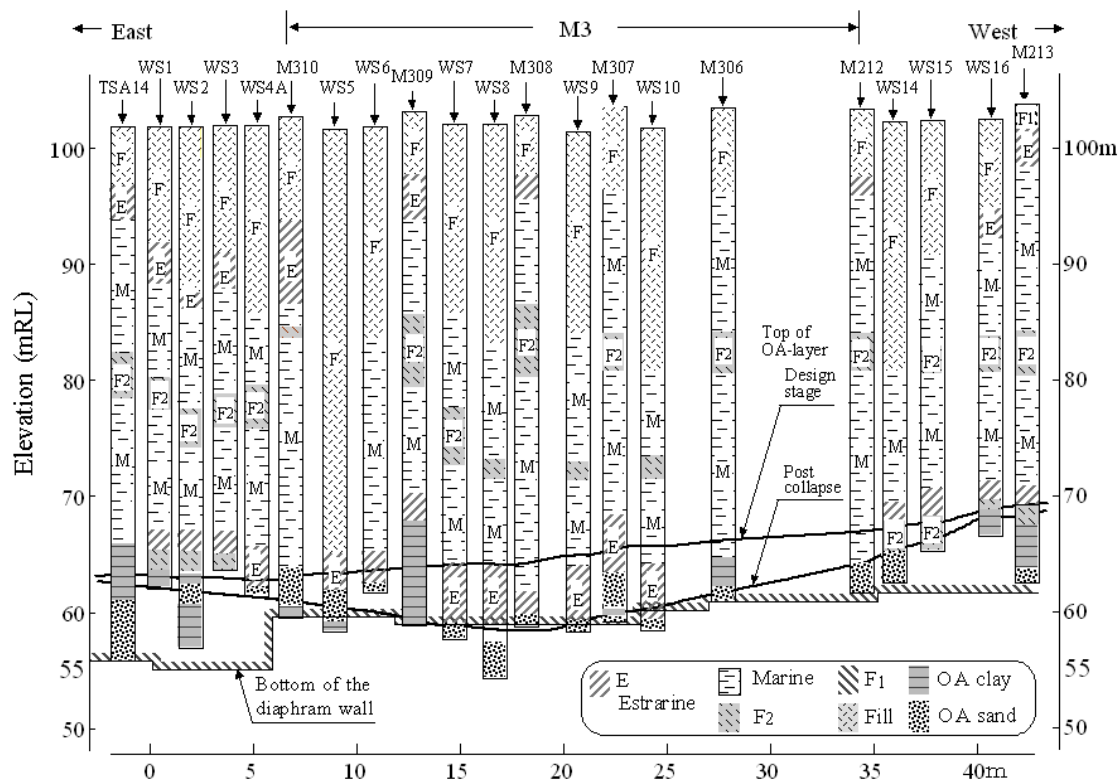
Fig. 17. Soil profile along the south wall and bottom of the diaphragm wall.

At the same time, settlements of the order of 5-10m are envisioned to have occurred in the upper part of the OA layer, as inferred from the settlements of the upper lying layer F_2 , as shown in Figs. 13 and 15, which was confirmed by the post collapse boring data. From the records of the diaphragm wall construction, the bottom line of the wall before the collapse is known and it is shown together in Fig. 17.

By comparing the elevations at the top of the OA layer before the collapse with those of the bottom of the diaphragm wall, it can be seen from Fig. 17 that in the eastern zone between WS1 and WS4A, the toe-in of the wall was more than 3m. In the zone of collapse between WS5 and WS16, the toe of the diaphragm wall seems not to be embedded sufficiently deep. However, the depth of embedment into the OA layer may be considered deeper than 3m in consistence with that considered in the design. It is to be pointed out, however, that the quality of the soils at the upper part of the OA layer was less competent in stiffness or strength as compared to that assumed at the time of the design. This point would have a more important bearing from the forensic point of view.

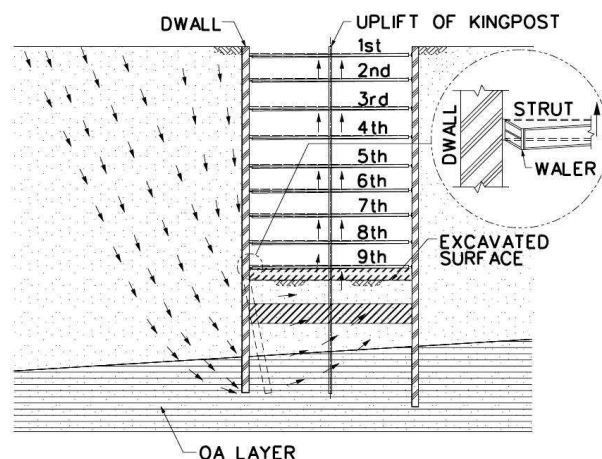
Fig. 19. Probable movements of soils near the toe of the diaphragm wall, and uplifting of the kingpost and sag of the wall leading to buckling and offset between strut and layer.

- (3) This uplift, combined with the sag of the wall must have caused the local buckling or breakage of the flange of the H-beams at connection between the walers and struts, creating as much as 20cm vertical offset as illustrated in Fig. 20. As a result, the net length of the struts was shortened and diaphragm wall must have deformed further inwards.

- (5) With the loss of functioning of the waler-strut system and increased inward movement of the wall panel toe, the integrity of the structural support as a whole was completely lost, leading eventually to the total collapse. This is illustrated in Fig. 20.
